Good Hope Mine, Circa 1900

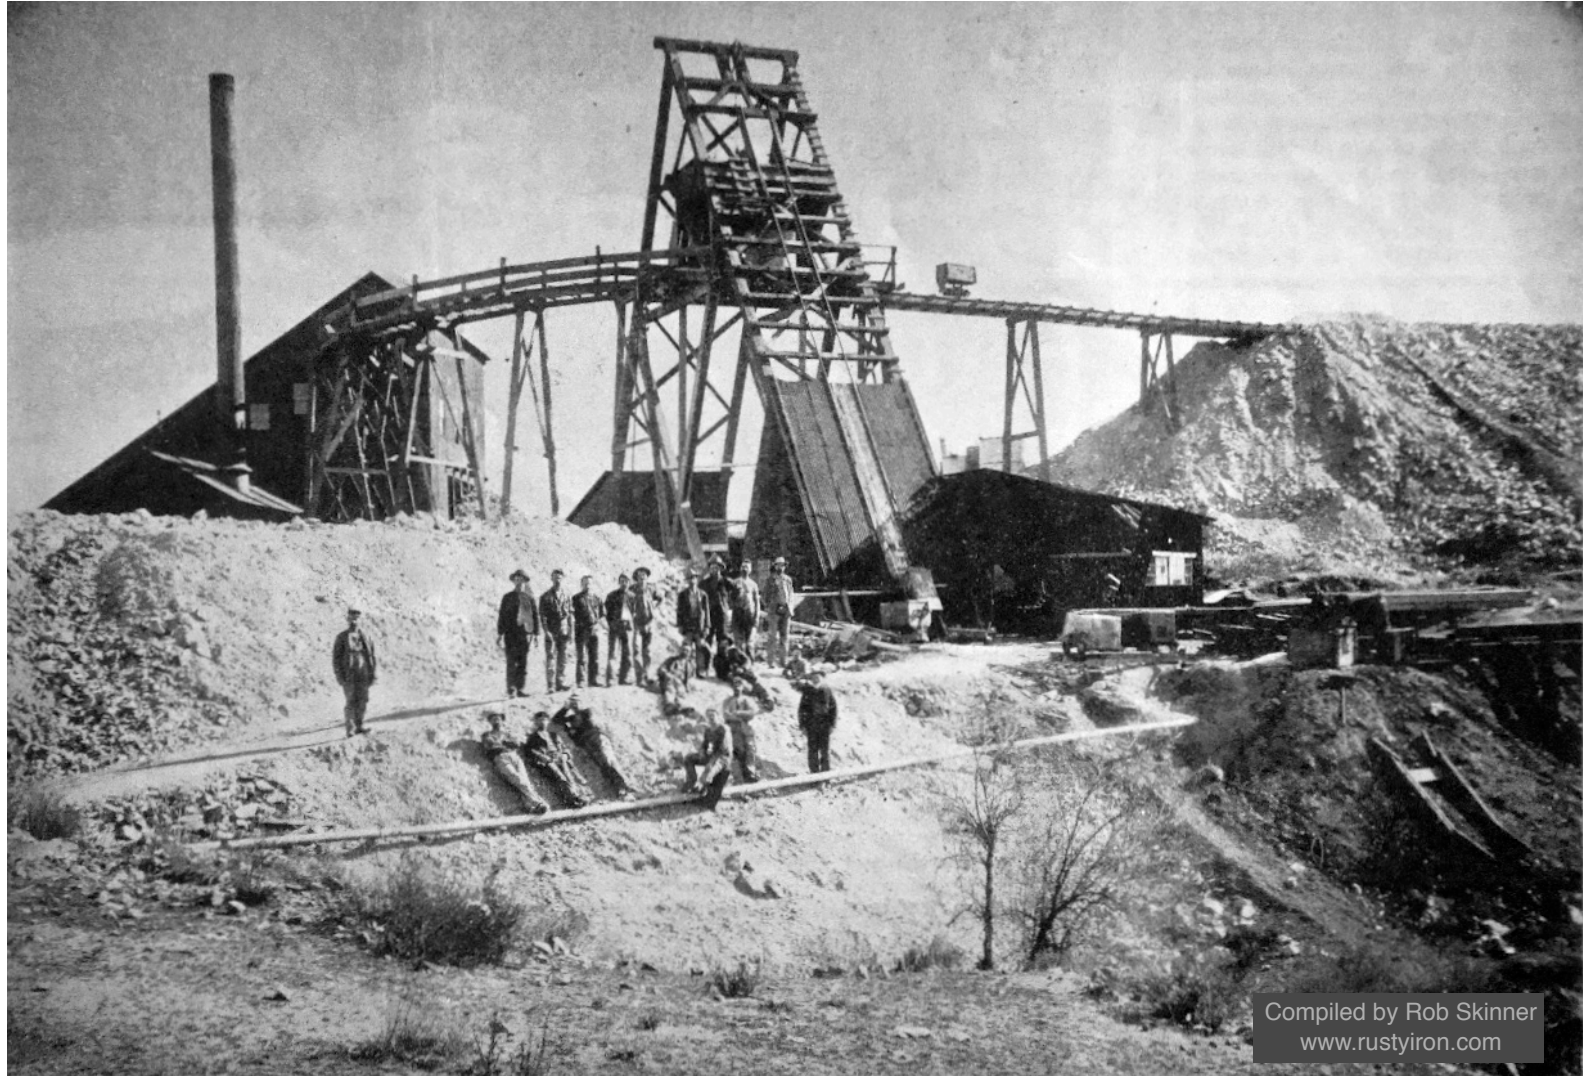
The accompanying photograph was taken near the main shaft, and shows a somewhat unusual headframe, with tramways leading to the mill and to the waste dump.
